Manhasset Union Free School District

**Districtwide Lead in Drinking Water
Sampling and Remediation Plan**

Project #19488

December 2020

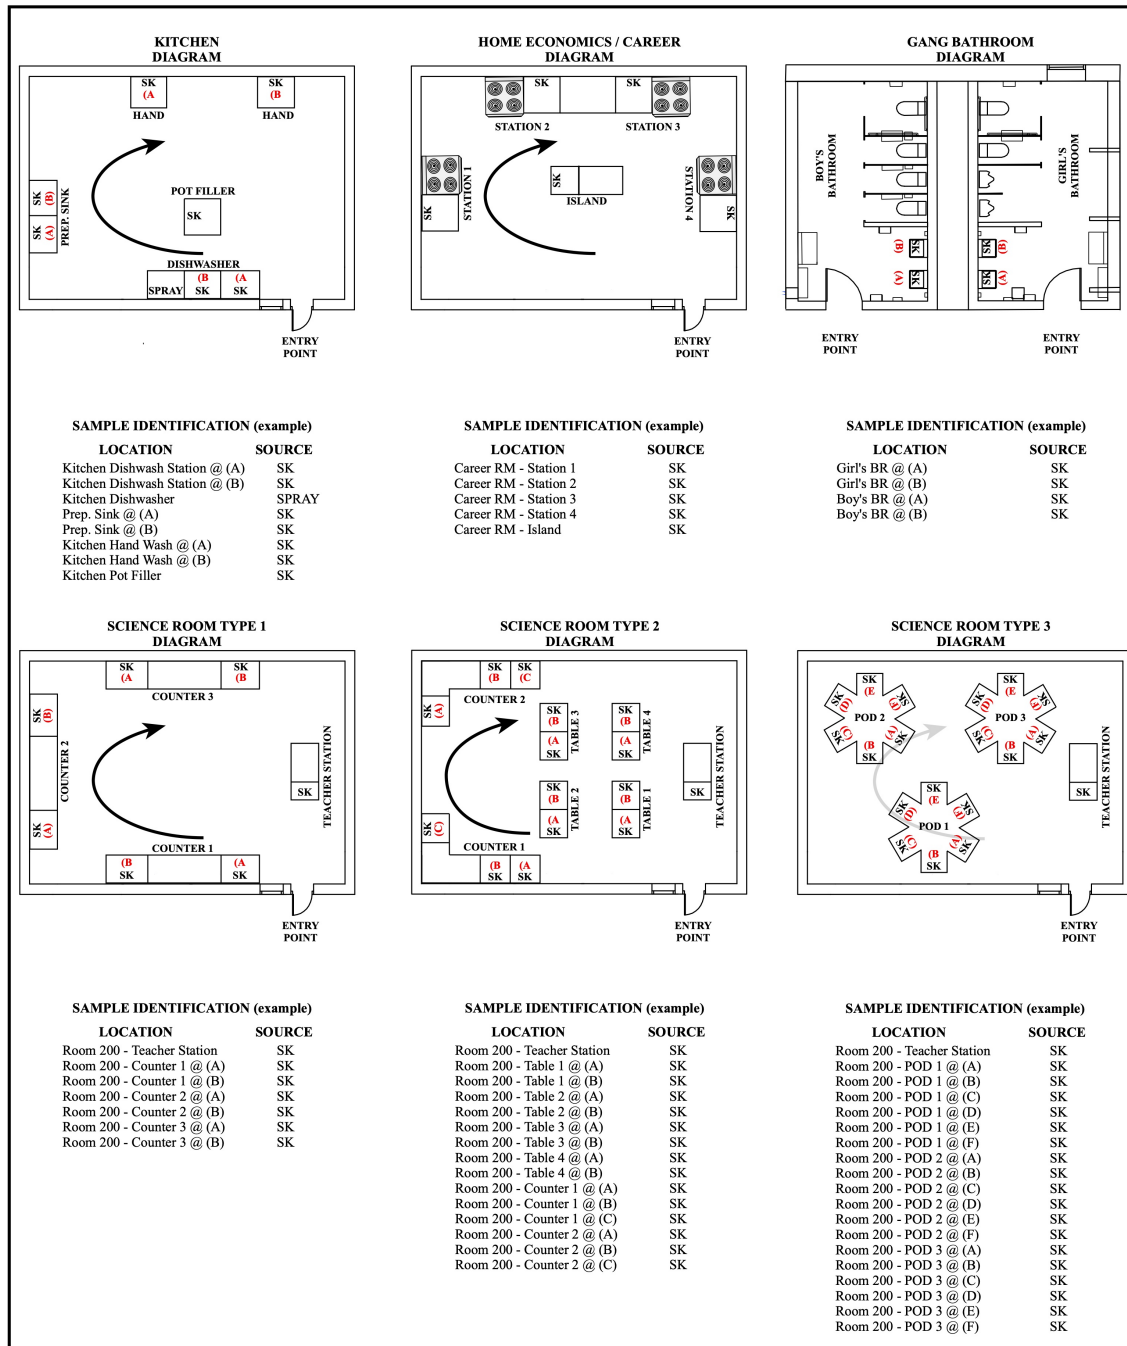
Sampling Location Schematics

In accordance with the regulation, EnviroScience Consultants, Inc. performed initial water sampling throughout the Manhasset Union Free School District on December 10, 2020. Samples were collected in wide-mouth 250 milliliter containers and were collected in the morning hours before the facilities opened. The water sources were not used for at least 8 hours and not more than 18 hours prior to sampling. Unique source numbers and designations were assigned to each source location. Unique sample identification numbers were assigned to each sample taken. The key to fixture type codes and the sampling location schematics are shown below.
